**CONNECTICUT RIVER BASIN
CONWAY, MASSACHUSETTS**

**ROARING BROOK DAM
MA 01056**

**PHASE I INSPECTION REPORT
NATIONAL DAM INSPECTION PROGRAM**

AUGUST 1981

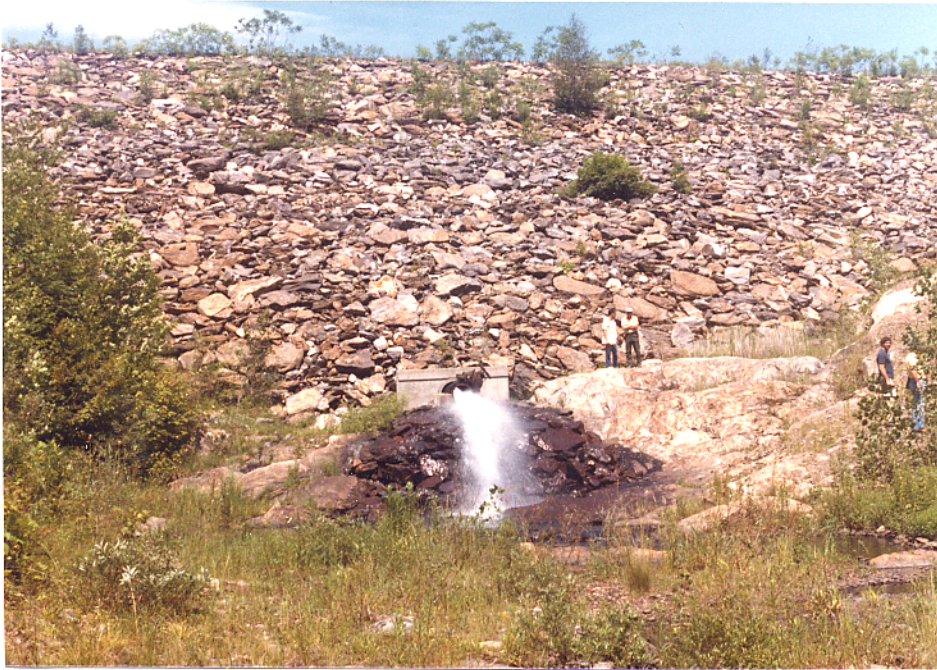
PHOTO NO. 1 - Downstream slope from outlet channel.

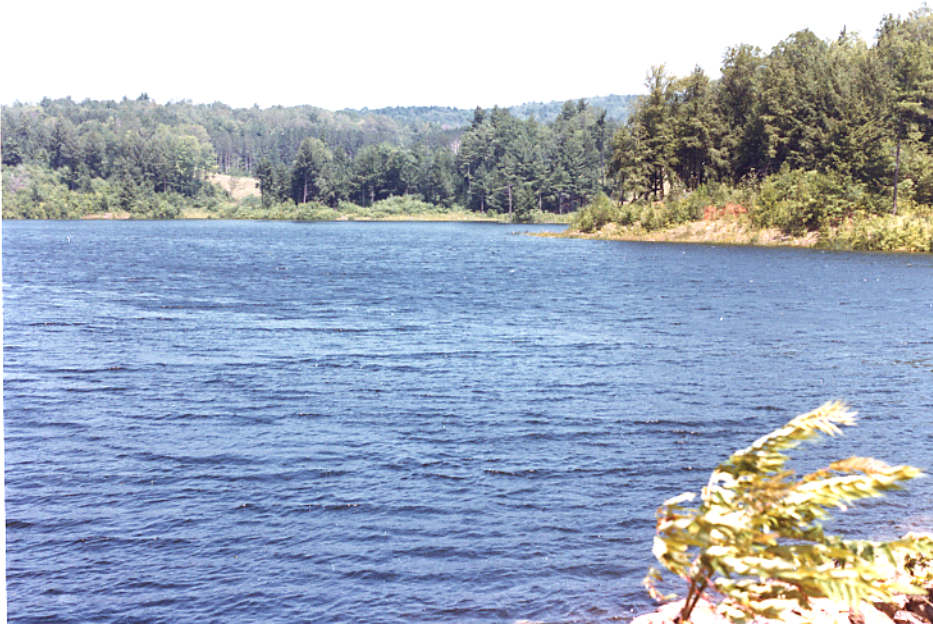
PHOTO NO. 2 - Reservoir viewed from dam crest.

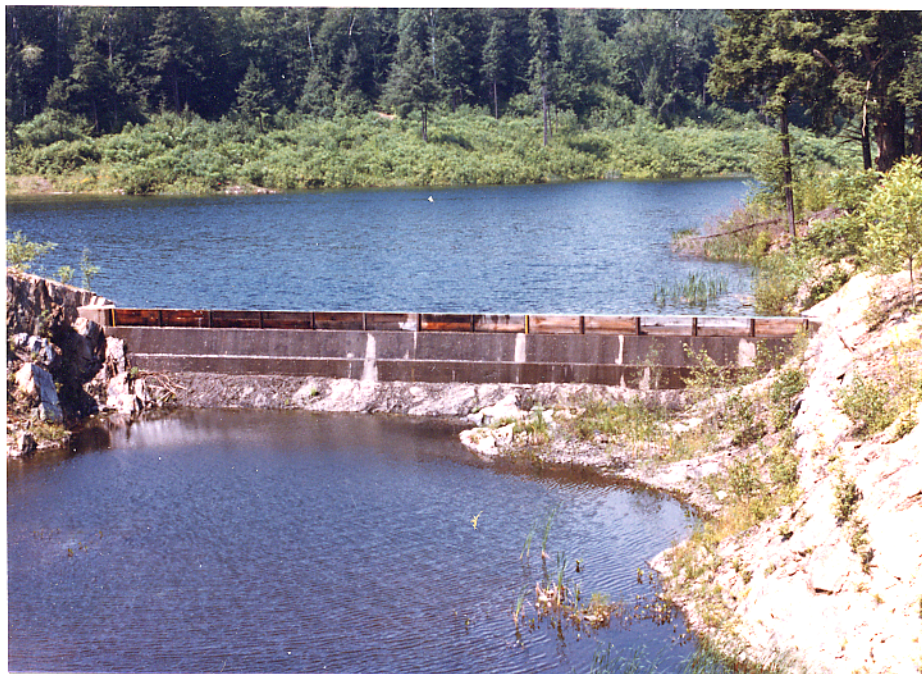
PHOTO NO. 3 - Downstream face of spillway.

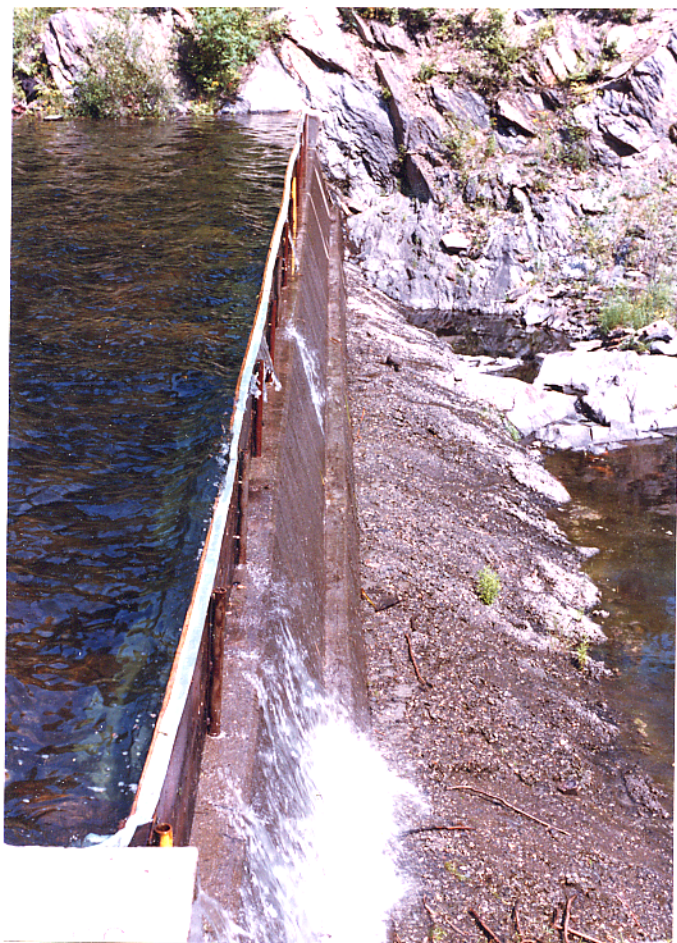
The spillway channel is cut out of bedrock in the left abutment as shown in photograph 4. The walls and channel floor are in good condition with no significant loose rock or debris.

PHOTO NO. 4 - Crest of spillway.

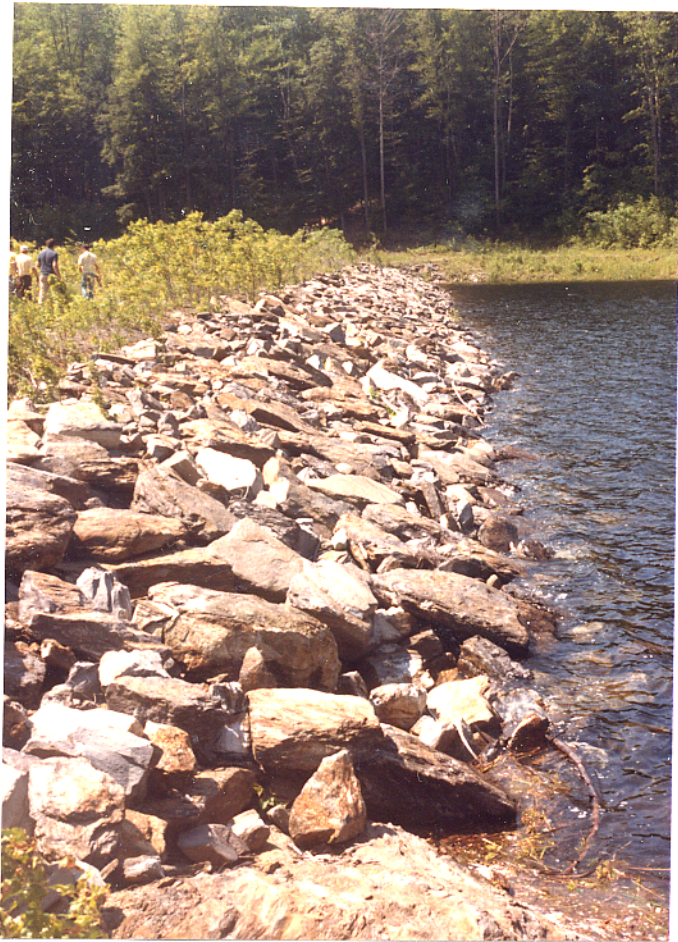
The upstream face of the dam has a slope of 2.5H:1V and is shown in photograph 5. The riprap above the reservoir level is in good condition.

PHOTO NO. 5 - Upstream slope from
spillway.

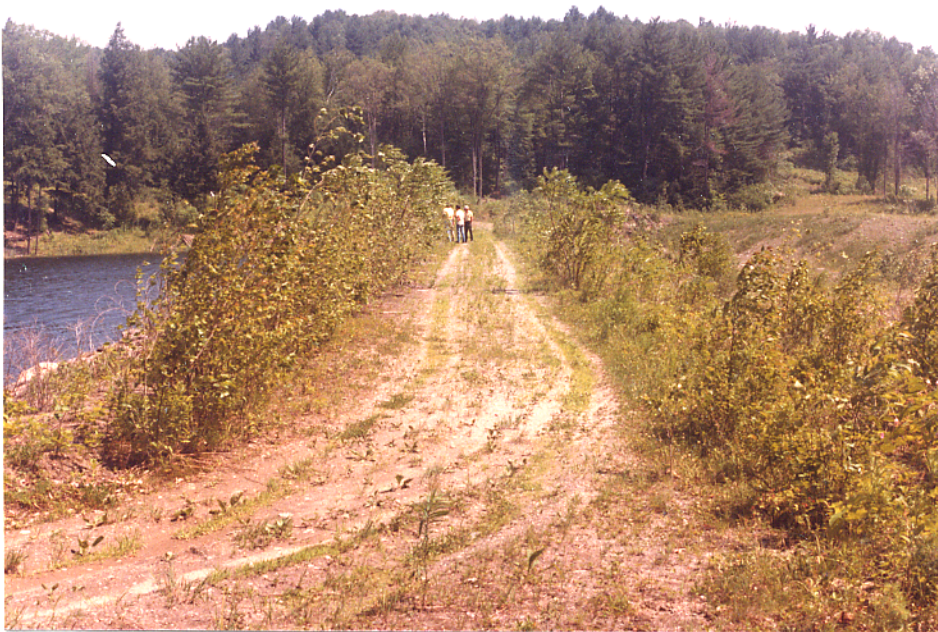
Instrumentation System	None observed.
Vegetation	Some brush on crest and downstream slope.

PHOTO NO. 6 - Crest from right abutment.

The Owner should institute remedial measures which include: cutting of brush growth on the crest and downstream slope; cutting of trees at the junction of the spillway discharge channel and outlet discharge channel; develop a formal downstream warning system and institute a program of annual technical inspection.

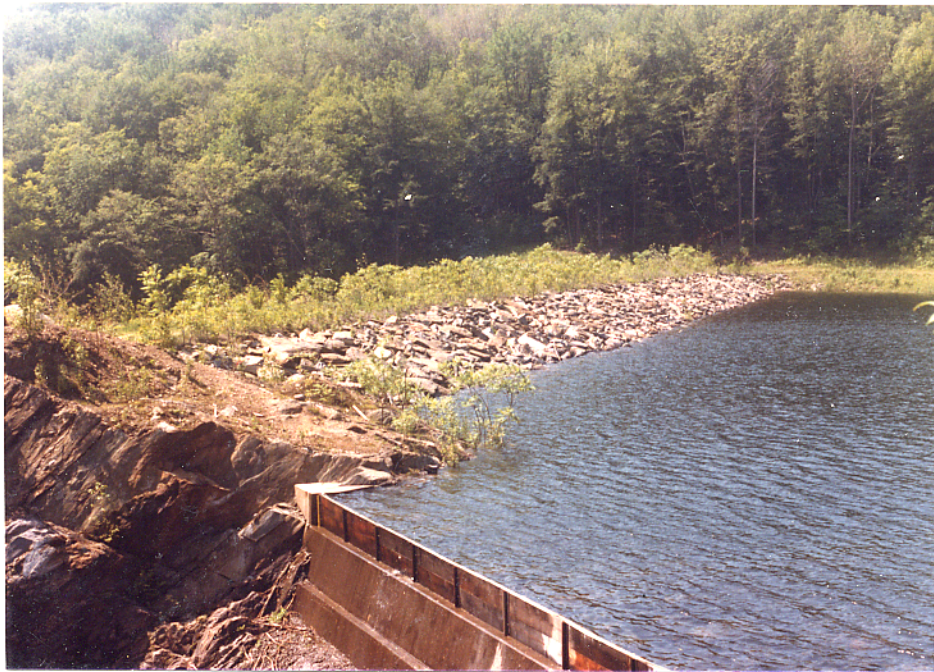
PHOTO NO. 7 - Upstream slope of dam from left abutment.

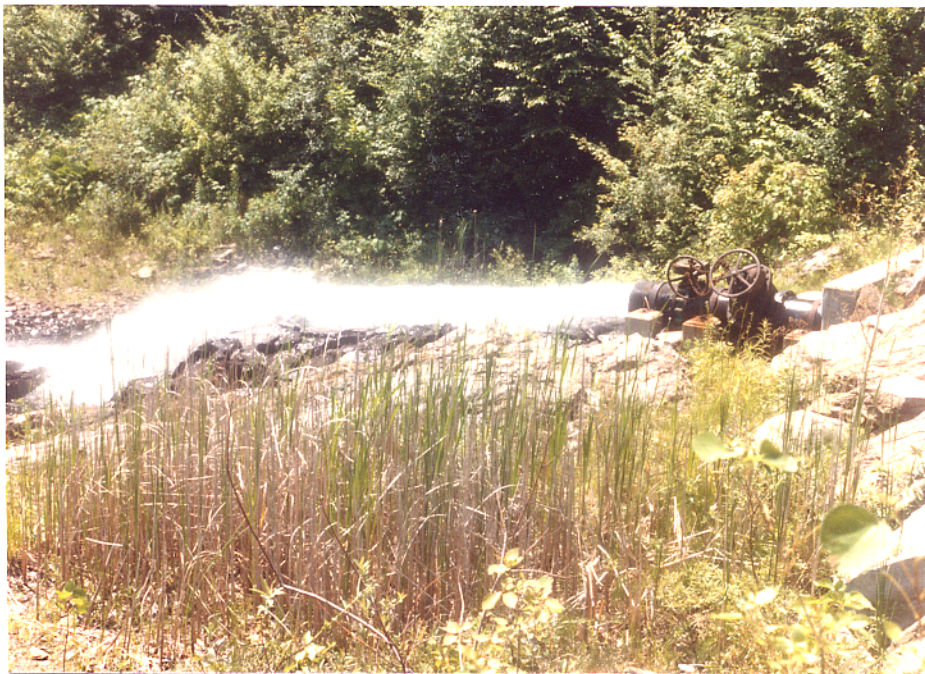
The gates at the outlet structure shown in photograph 8 are operated frequently and appear to be in good condition. The controls at the inlet are underwater and not readily accessible.

PHOTO NO. 8 - Dried swamp grass at downstream toe on left side of gated outlet structure.

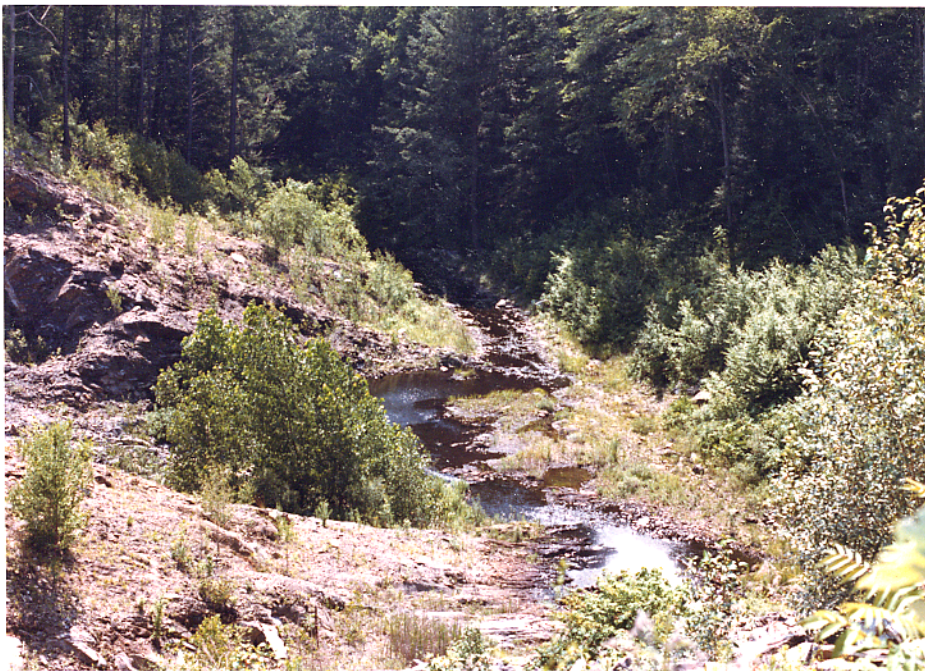
The outlet discharge channel is in good condition and free of obstructions.

PHOTO NO. 9 - Outlet structure discharge channel.

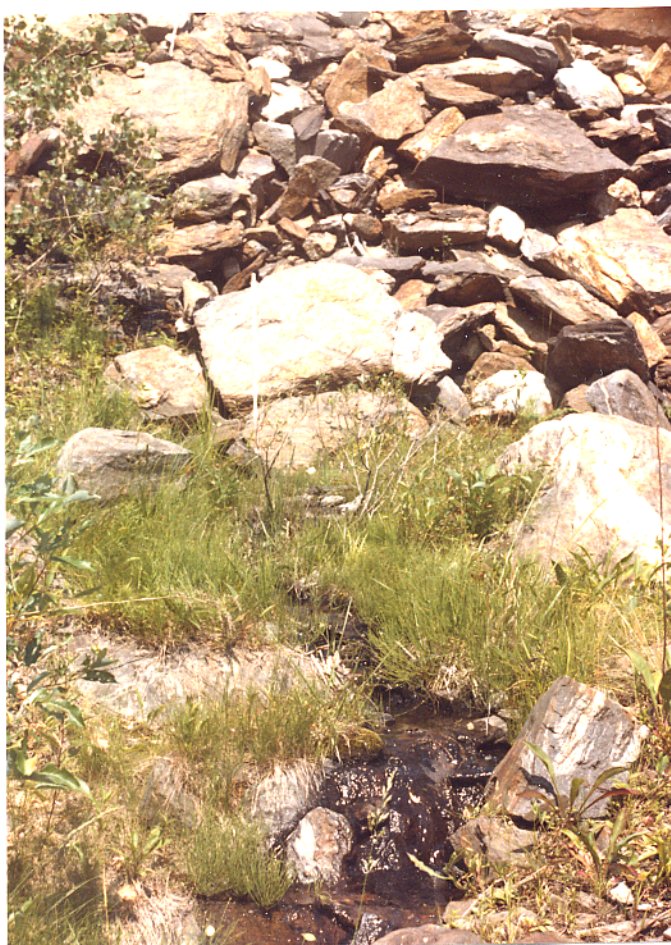
Seepage on the order of 2 gallons per minute was flowing from an area on the right side of the outlet pipe (looking downstream). This seepage is shown in photograph 10 and appears clear and no evidence of soil erosion is present. On a subsequent visit to the dam on July 31, 1981, a second area of seepage on the left side of the outlet pipe was observed with a flow rate on the order of 1 gpm. This seepage, shown in photograph 12, was also very clear.

Based on the design of the dam, it is probable that the seepage appearing at the toe of the dam is well filtered and at the present rate of flow is not likely to cause internal erosion of the dam.

PHOTO NO. 10 - Seepage of about 2 GPM from toe of dam on right side of outlet pipe.

It is recommended that the Owner engage a qualified registered professional engineer to: design and implement the construction of a weir to monitor seepage and a service bridge to provide upstream access to the controls for the drain; evaluate the stability of the downstream slope of the dam under all design conditions.

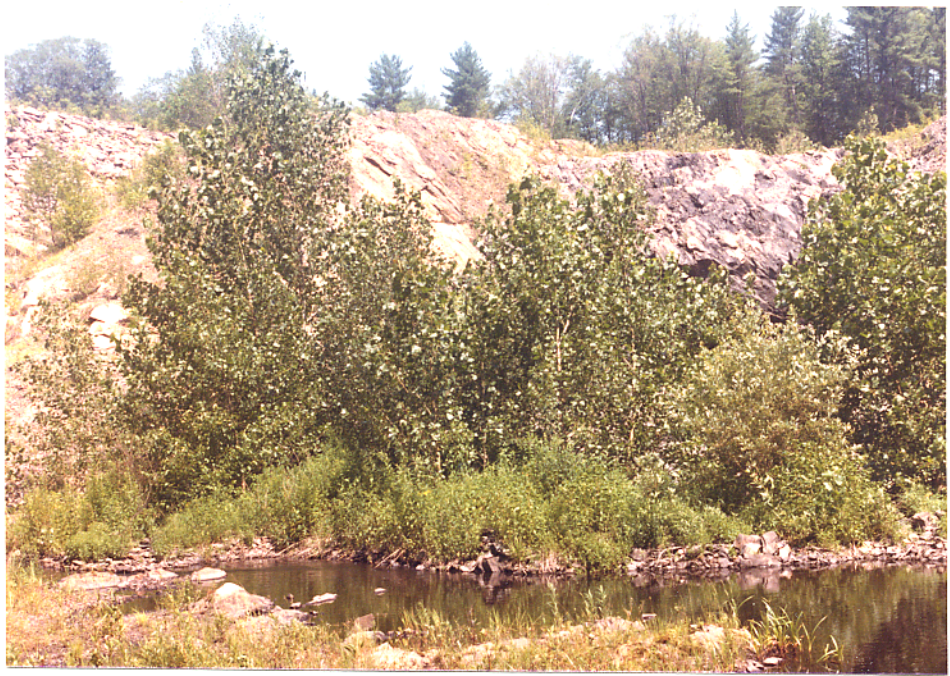
Both the spillway discharge channel and outlet discharge channel are in good condition except for the trees growing at the intersection of these channels.

PHOTO NO. 11 - Trees at junction of spillway discharge channel with outlet channel in foreground.

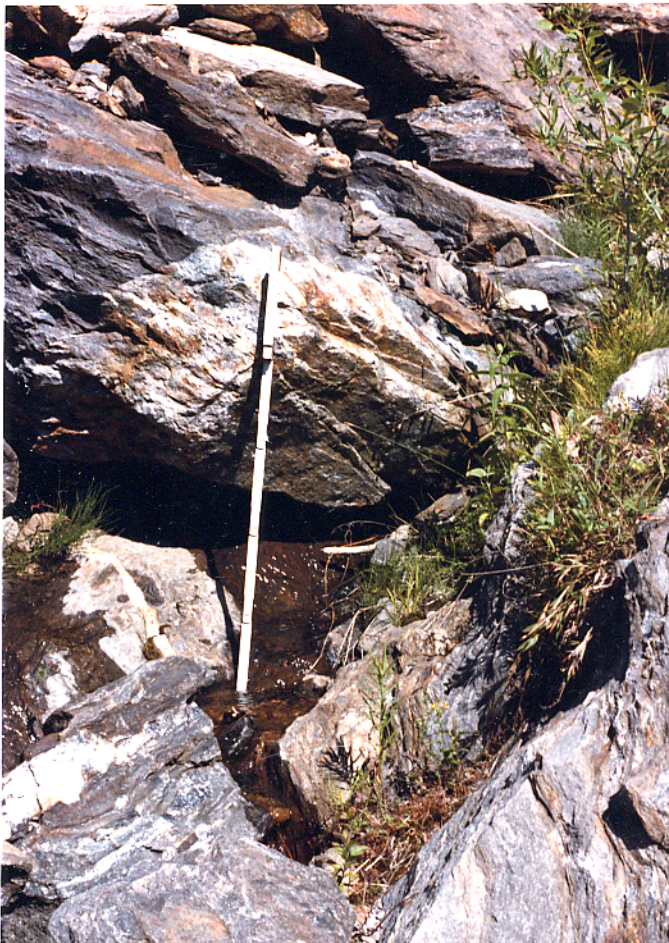
PHOTO NO. 12 - Seepage of about 1-2 gpm from toe of dam on left side of outlet pipe.
